Transportation Safety Board
of Canada

Bureau de la sécurité des transports
du Canada

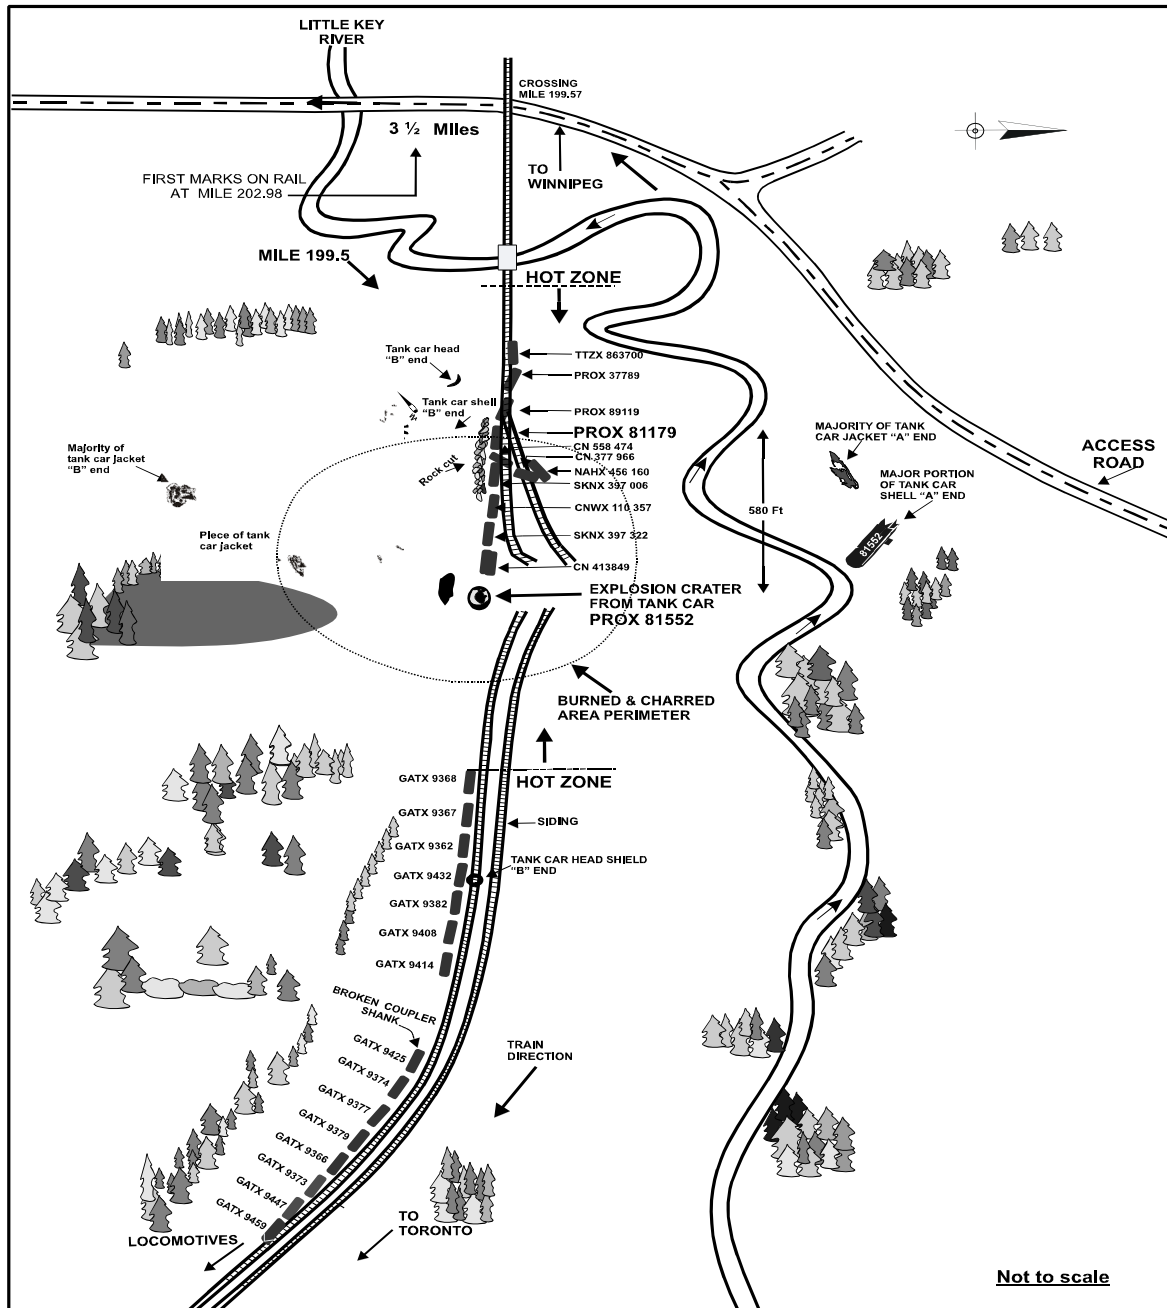
Figure 2—Derailment schematic

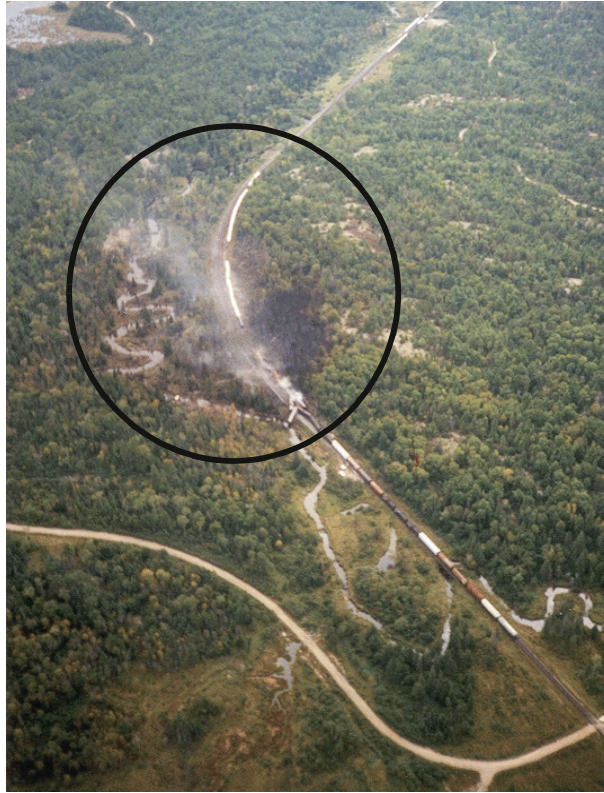
Figure 3—Aerial photograph of derailment site from the northwest. The circle denotes blackened area from fire damage. Note the public crossing at the bottom right. Note the direction of smoke and fumes, and the location of Little Key River adjacent to the right-of-way.

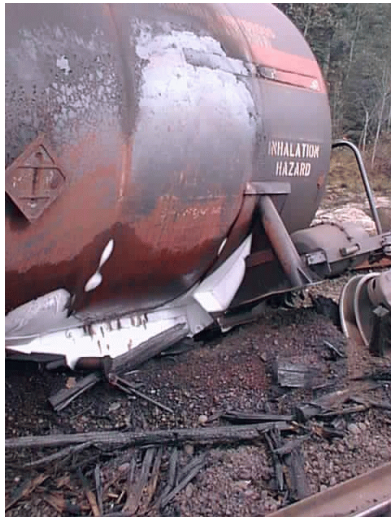
Figure 4—Some of the fire damage to tank car PROX 81179

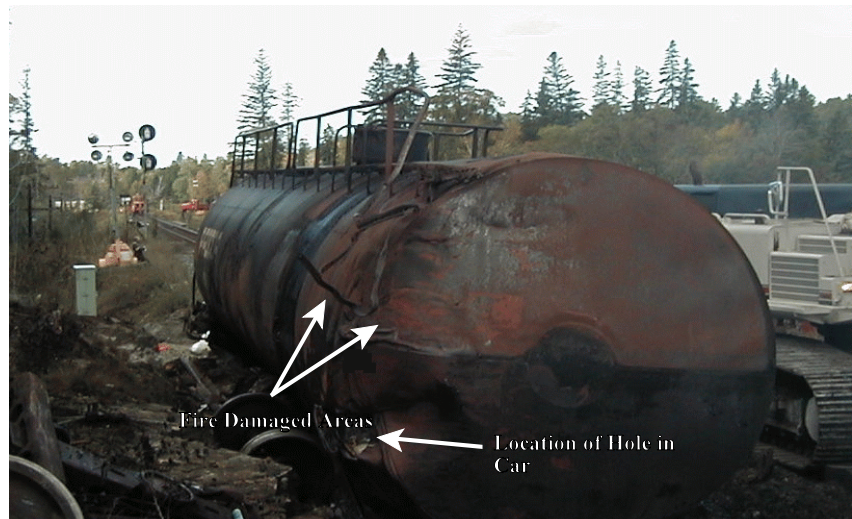
Figure 5—Fire damage and hole to “A” end (non-hand brake end) of car PROX 81179

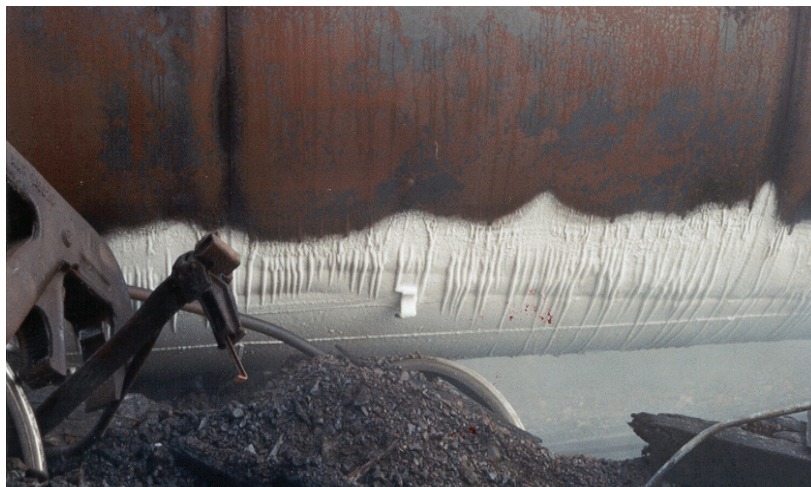
Figure 6—Due to thermal conductivity, frosting extends upward from the 10 inches of refrigerated product remaining in car PROX 81179

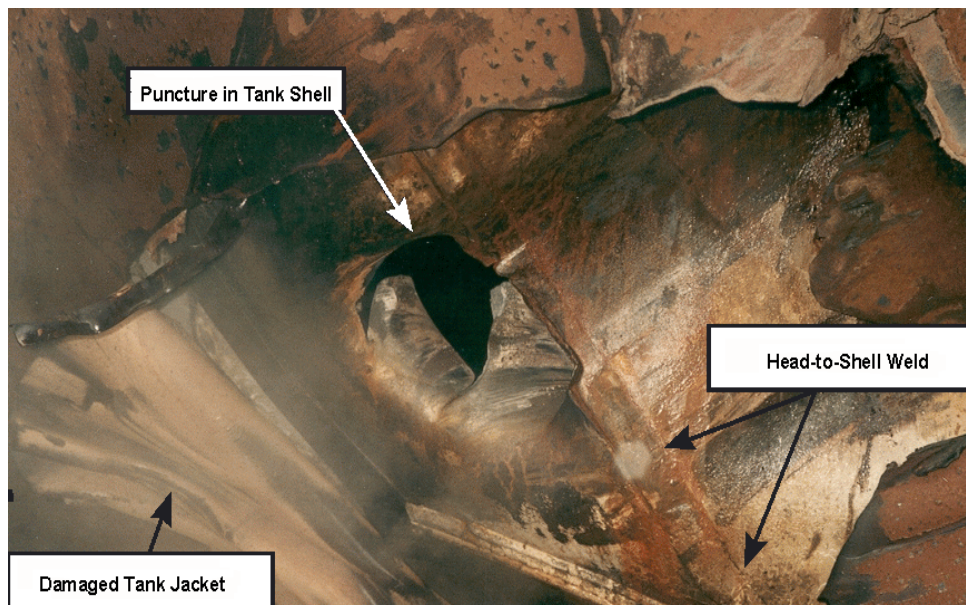
Figure 7—Hole in shell at AR location on anhydrous ammonia tank car PROX 81179

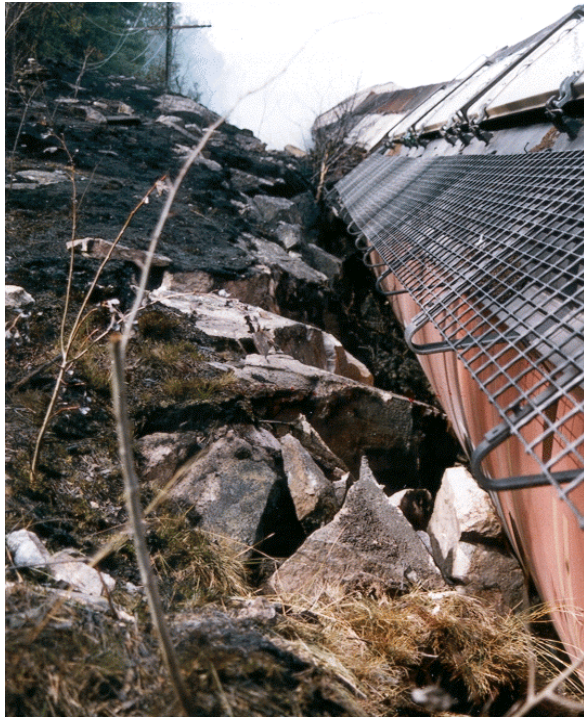
Figure 8—Side of derailed car resting against a rock cut on the inside of the curve (south side of the main track)

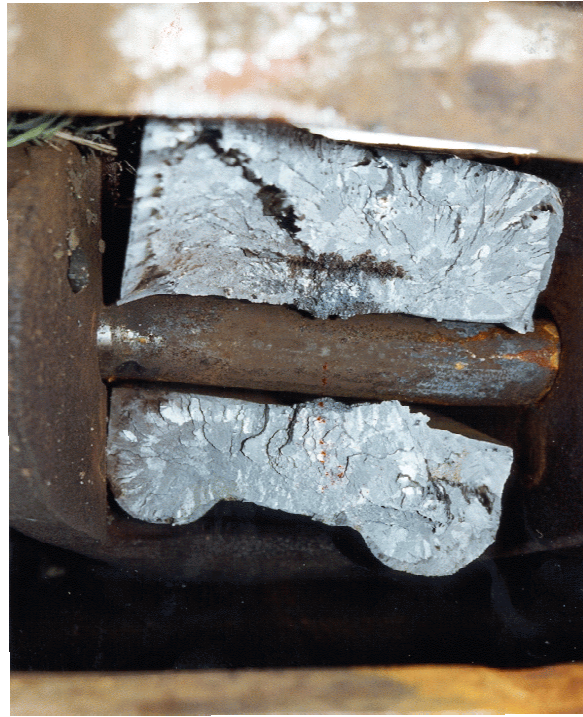
Figure 9—Broken coupler shank on car GATX 9425 indicating significant longitudinal in-train forces during the derailment

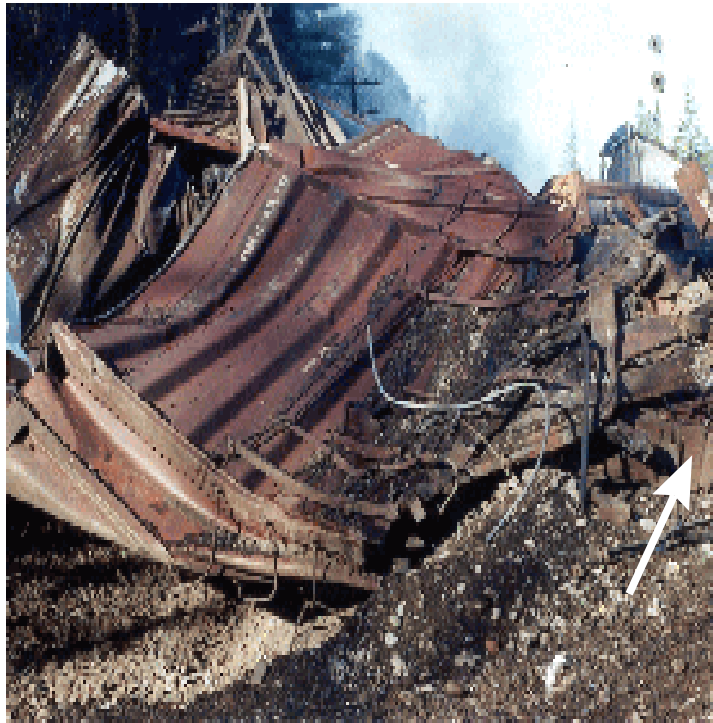
Figure 10—Impact damage to box car CN 413849 as viewed looking west from crater in right-of-way. Arrow points to centre sill which was bent 90 degrees to the north.

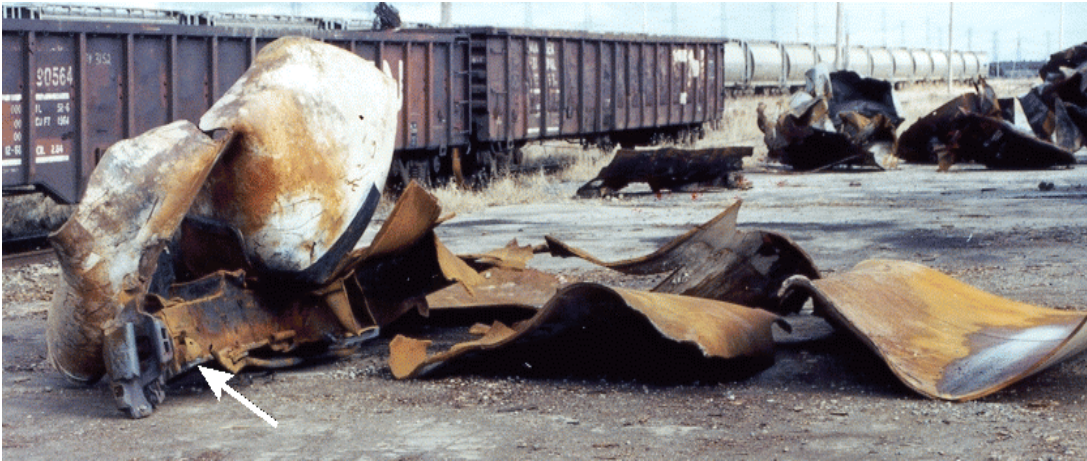
Figure 11—Main part of the “B” end of the car, including the head and approximately 16.5 feet of the flattened sections of the tank shell recovered after the derailment. (The coupler and stub sill are in the foreground at the lower left.) The remaining pieces of the tank car and jacket can be seen in the right background.

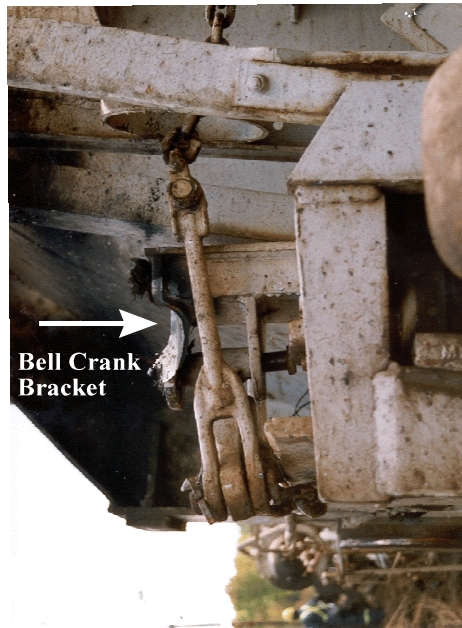
Figure 12—Damage to hand brake bell crank bracket on car GATX 9367

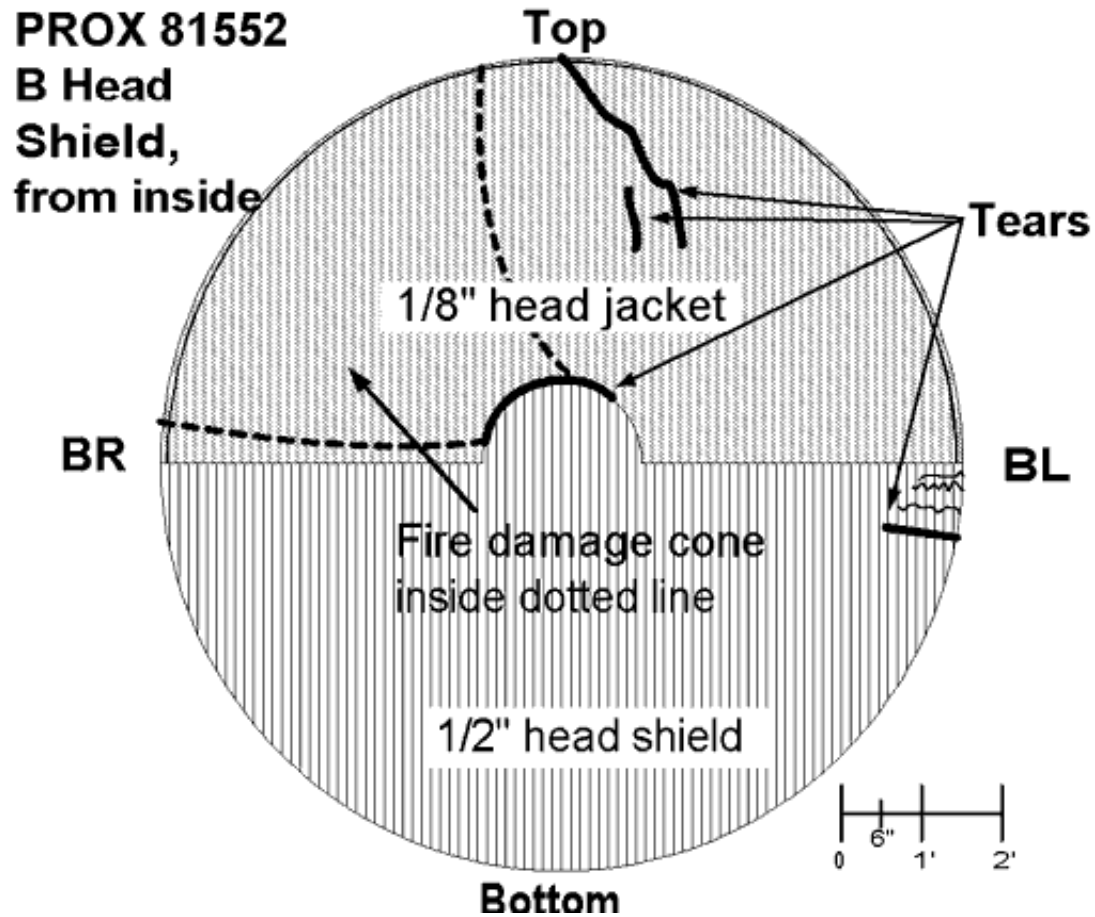
View of damage to head shield on "B" end of car PROX 81552
(Source: Transport Canada)

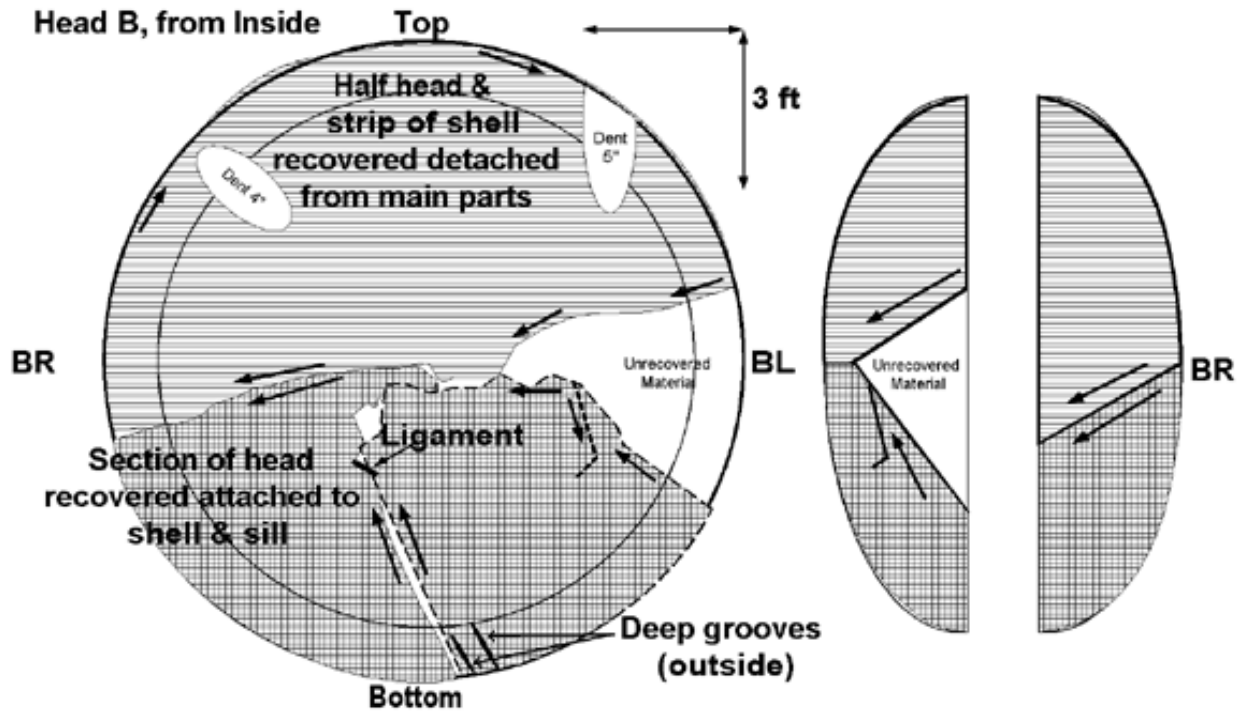
End and side view of damage to tank head on "B" end of car PROX 81552
 (Source: Transport Canada)

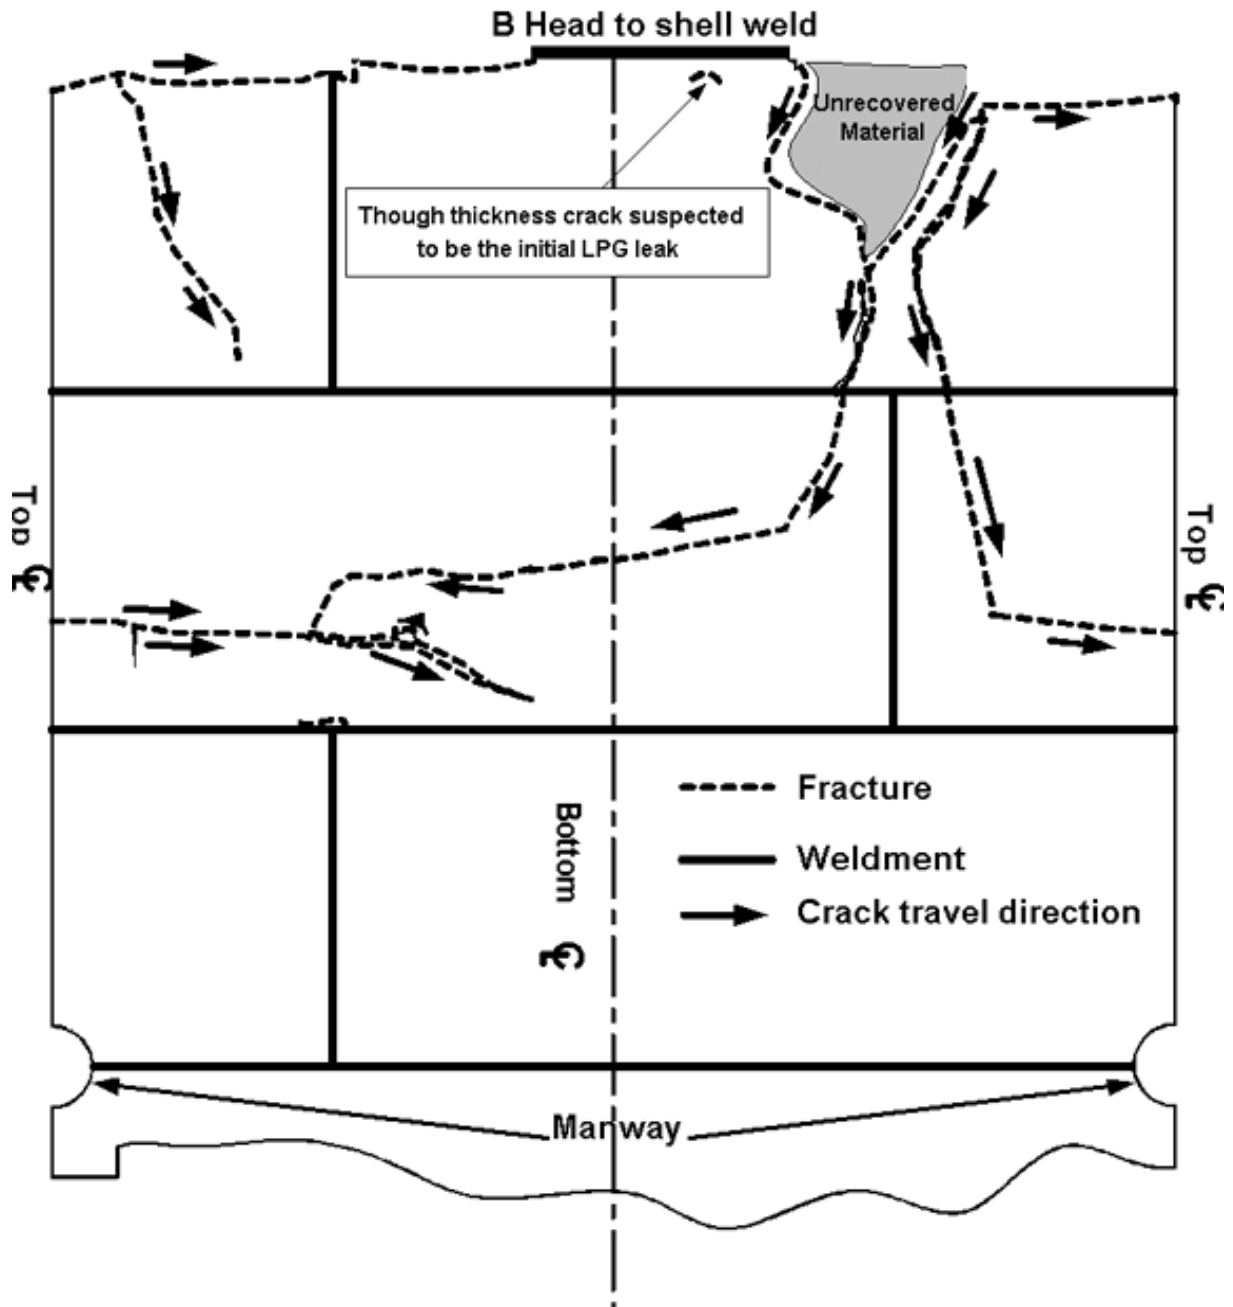
Flat view of fracture locations on "B" end of tank shell of car PROX 81552
 (Source: Transport Canada)

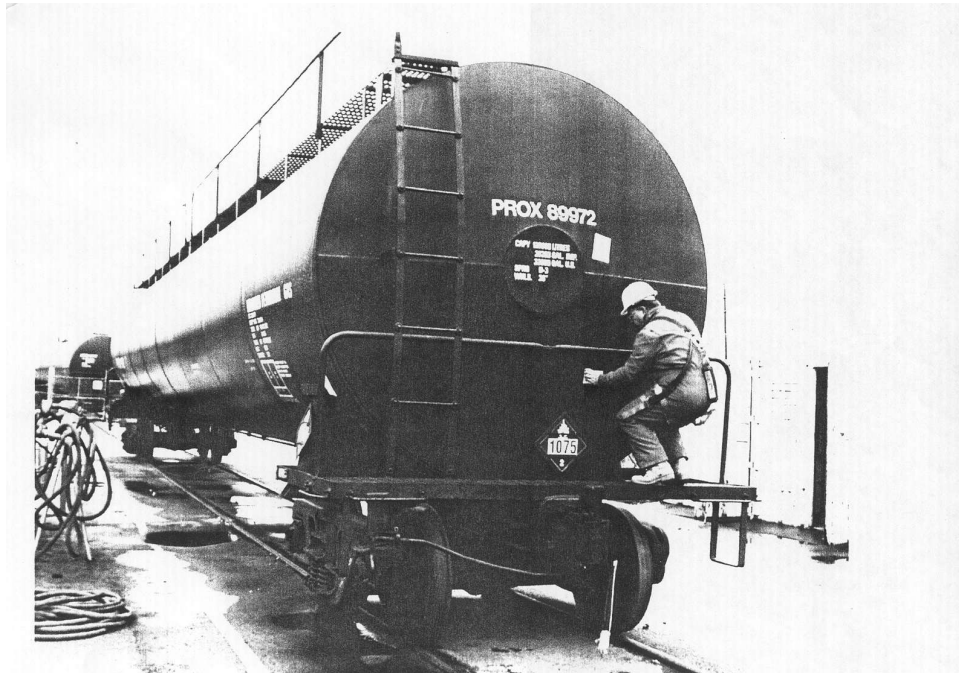
Examination of insulation at one of the inspection locations cut into the tank jacket

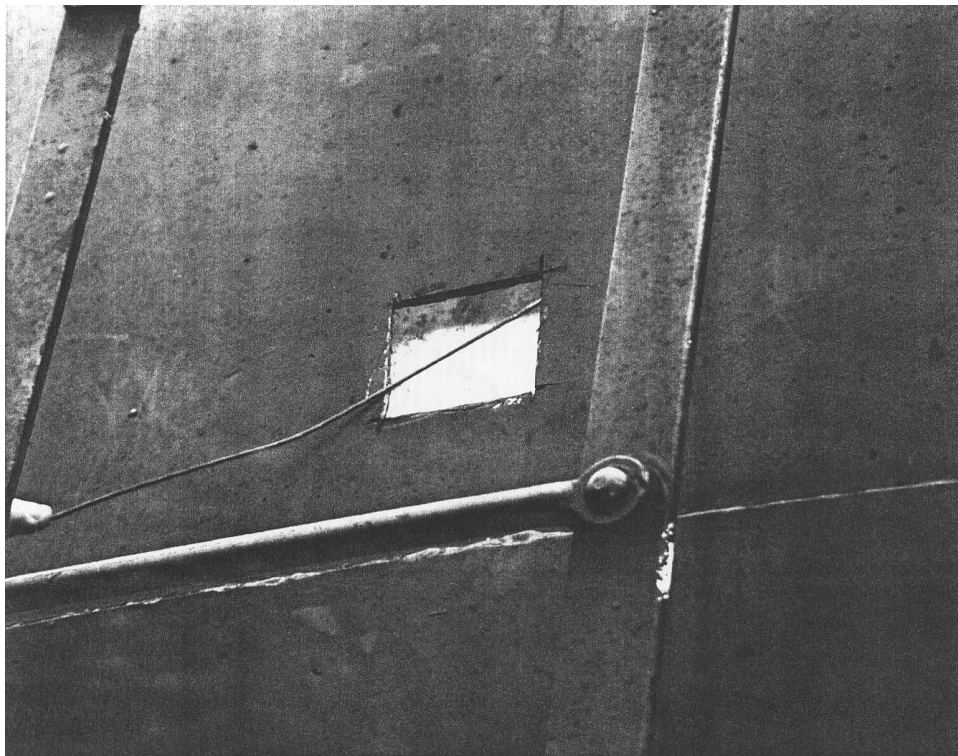
Close-up view of a typical inspection location
